Property Inspection Report

Charlie and Mary Sample Residential Inspection

Inspection Date:
11/20/06

330 Barnes Road

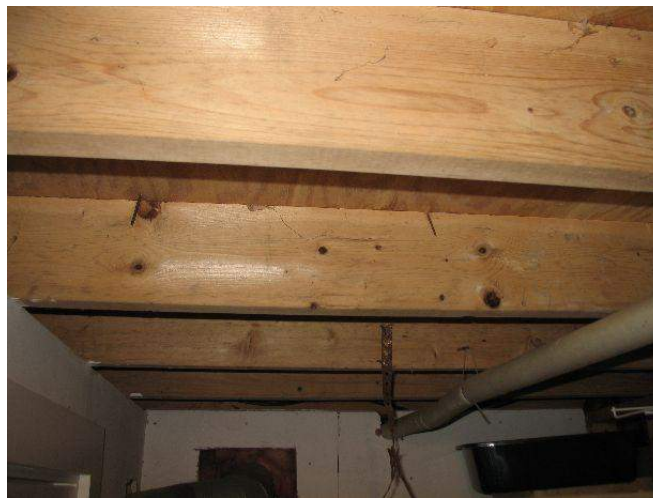
Figure 1

- Some of the original joists were replaced.
- Some of the original joists were replaced. See figure 1 below.

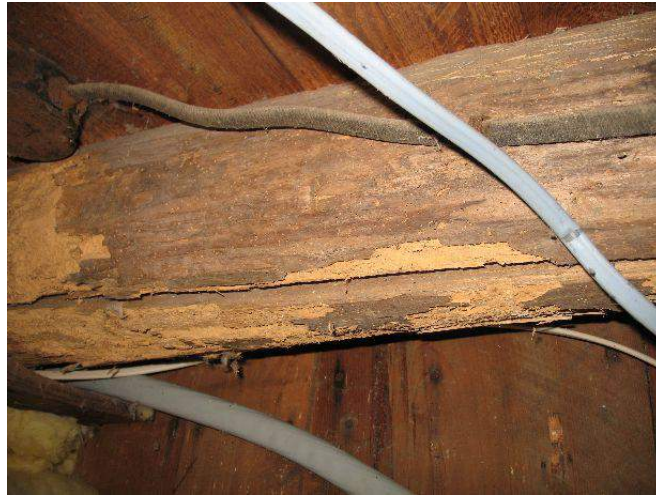
Figure 2

- There was evidence of powder post beetles. A quote was received from Putnam Pest Control for treatment and attached on page 33. See figure 2 below.

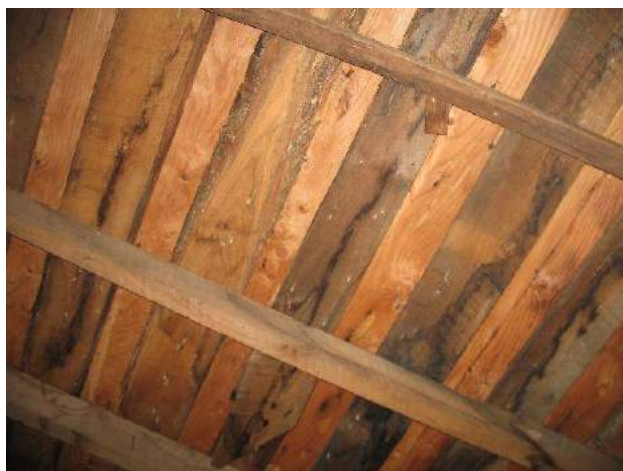
Figure 3

- Monitor: Any debris on the roof should be kept cleaned off as this debris will hold moisture and attract insects.
- Monitor: All roof penetrations should be monitored for leaks and inspected regularly to see if they need resealing.
- The roof sheathing is in good condition. See figure 3 below.

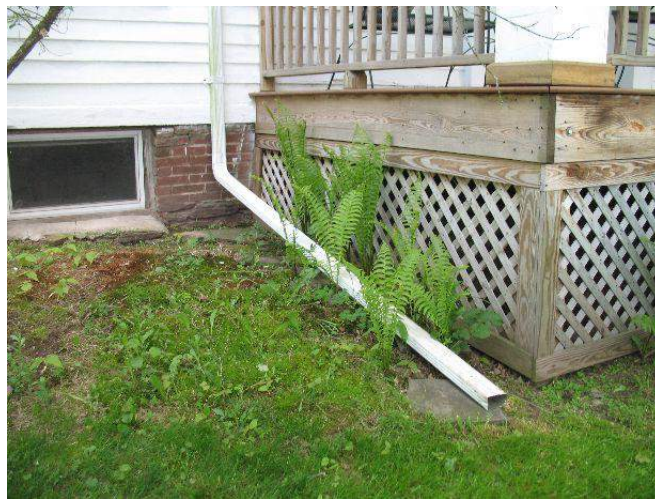
Figure 4

- Gutters and downspouts have been installed on the roofs of the structure.
- The gutters are metal and satisfactory.
- The downspouts discharge water at least five feet from the foundation or drain into a functioning subsurface drainage system. Storm water should be encouraged to flow away from the building at the point of discharge (a potential source of water entry into the basement).
- Monitor: The gutter system should be maintained and cleaned periodically or as needed.
- Improve: Subsurface drains should be checked periodically to make sure they are not clogged.
- Improve: Gutter extensions have been utilized. See figure 4 below.

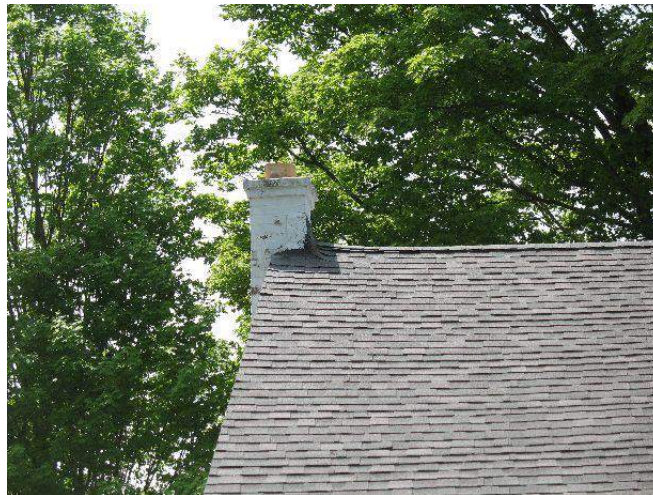
Figure 5

- The fireplace uses the brick chimney.
- The furnace uses the concrete block chimney.
- The fireplace chimney should be cleaned and the flue inspected before use.
- When the roof was installed an old chimney was removed below the roof line. It can still be seen in the attic.
- Improve: Wood for the fireplace is stored in the garage. This is not recommended as it holds moisture creating wood rot and attracts mice and insects. Stored outside covered is a better choice.
- A chimney cap and screen has been installed on the fireplace chimney. A cap and screen should be installed on the furnace chimney. This will keep water from entering the chimney and vermin animals from getting into the chimney. See figure 5 below.

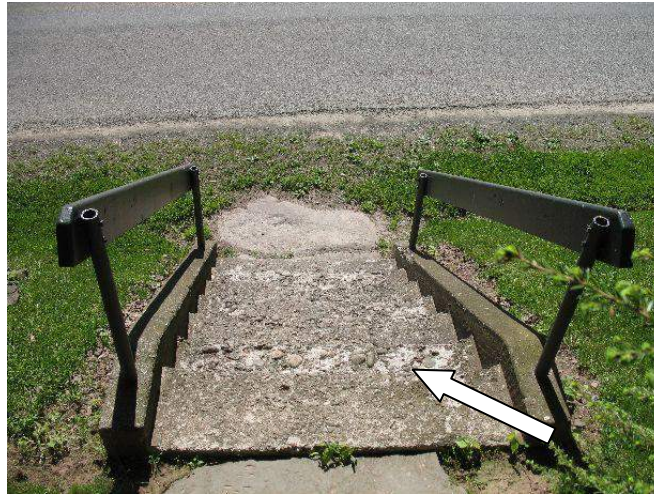
Figure 6

- Repair: All pipe and wire penetrations through the exterior walls should be sealed. Water leaking through non-sealed areas can cause structural damage.
- Repair: The exterior trim and wood window casings need a coat of paint.
- The outside of the home will need occasional painting.
- Monitor: The steps to the road have a handrail on both sides. The concrete is starting to deteriorate. See figure 6 on the next page.

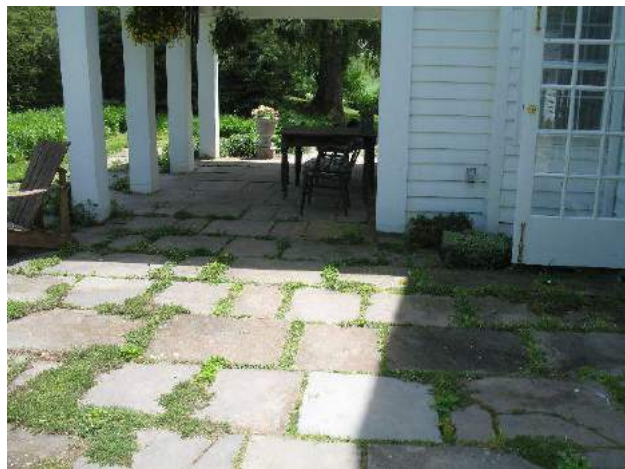
Figure 7

- There is a very nice private patio in the back yard. See figure 7 below.

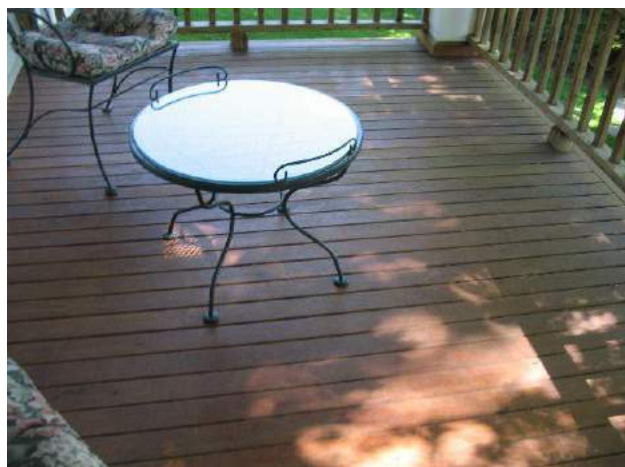
Figure 8

- The front porch has a very nice wood floor and railing with banisters. The ceiling will need a coat of paint. See figure 8 below.

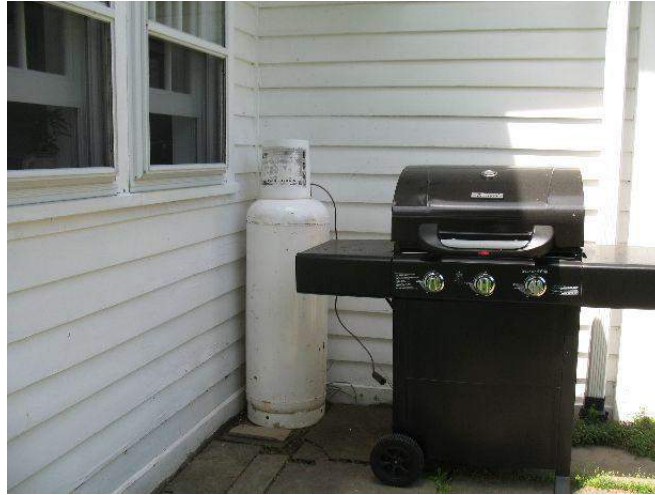
Figure 9

- **Safety Issue:** The 100 pound propane tank should not be stored within three feet of an opening in the structure. Also, please do not use the grill too close to the wood siding. See figure 9 above.
- **Repair:** All roof penetrations should be caulked where they abut the exterior of the home. This will aid in the prevention of water intrusion into the structure.

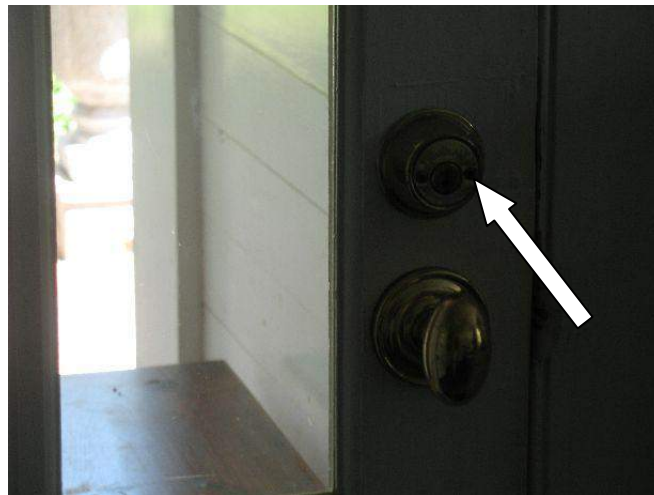
Figure 10

- **Safety Issue:** The exterior doors can only be unlocked from the inside with a key. This presents a serious hazard. They should be changed. See figure 10 below.
- **Improve:** It is recommended that all exterior doors have dead bolt locks and keyed alike.

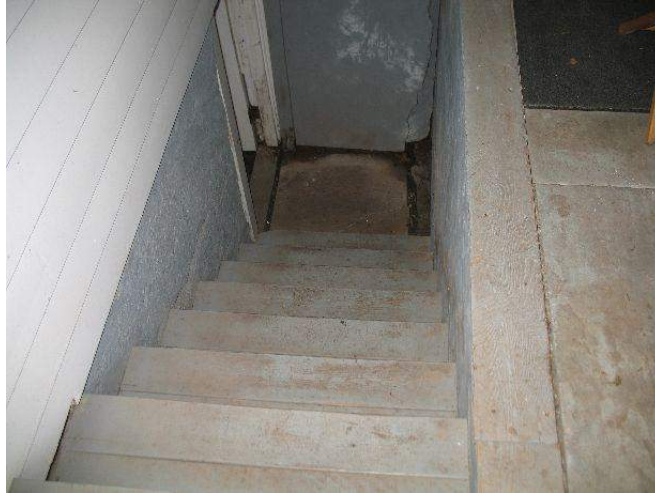
Figure 11

- The wall at the bottom of the stairs is moving. The ground level on the opposite side of the wall slopes towards the wall. There is a gutter entering a drain there also. The drain should be checked for proper operation and the ground sloped away from the structure.
- The basement stairs could use a railing on both sides and a railing around the top of the opening. See figure 11 below.

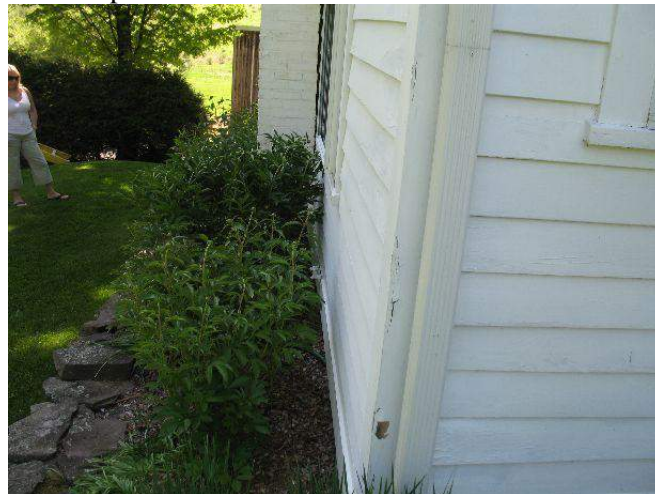
Figure 12

- Repair: Vegetation should be kept back at least 16 inches from the structure. See figure 12 below.

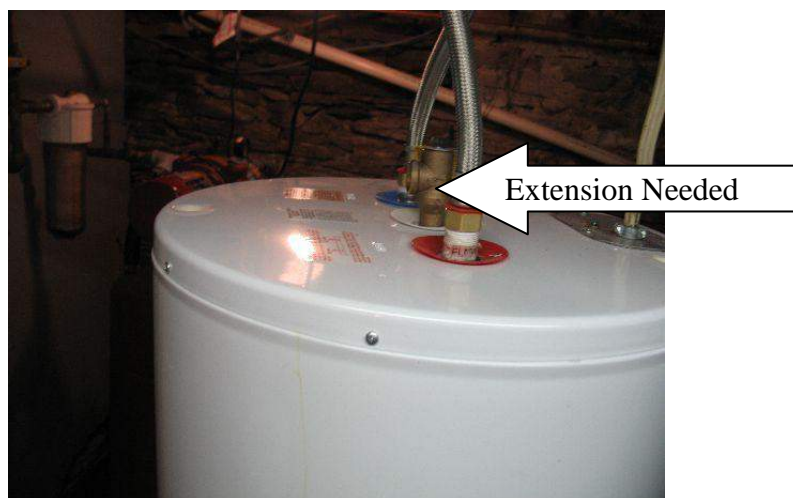
Figure 13

- The hot water pressure relief valve on the hot water heater was 150 psi and needs an extension installed which should be extended to 6 to 8 inches from the floor. See figure 13 below.

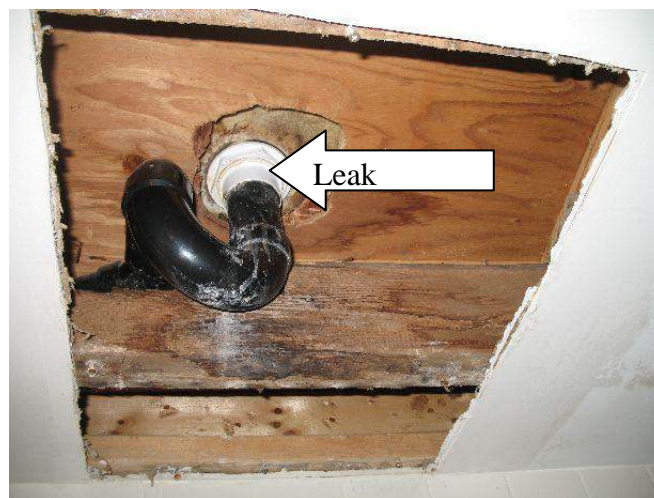
Figure 14

- Repair: There is a water leak in the upstairs shower and drips into the down stairs tub. The owner stated that this will be repaired. See figure 14 below.

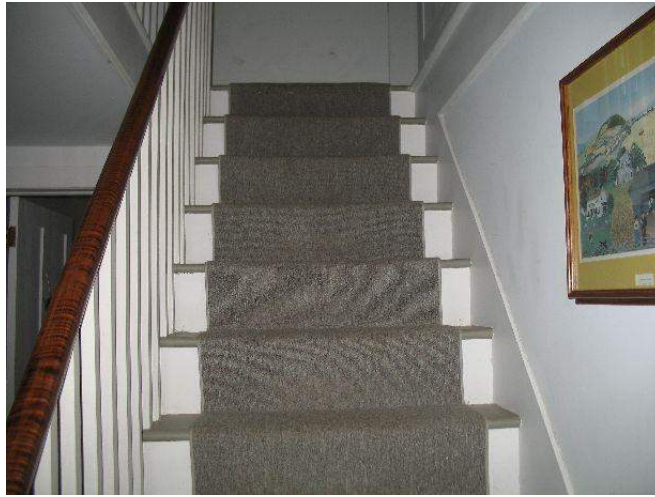
Figure 15

- The windows are single pane and most had storms.
- Samples of the windows operated were found to function satisfactory.
- Improve: The inside wood of the windows could use wood treatment.
- Improve: The stairs to the second floor need a handrail installed on both sides of the stairs. Notice the very beautiful railing. A very beautiful accent to the home. See figure 15 on the next page.

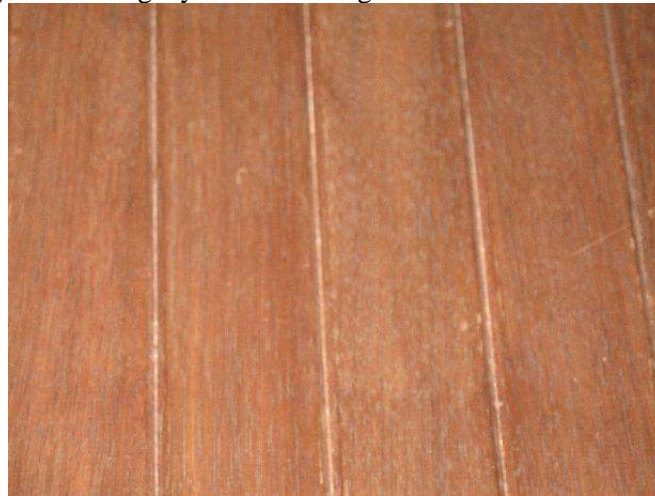
Figure 16

- The kitchen floor is very nice mahogany wood. See figure 16 below.

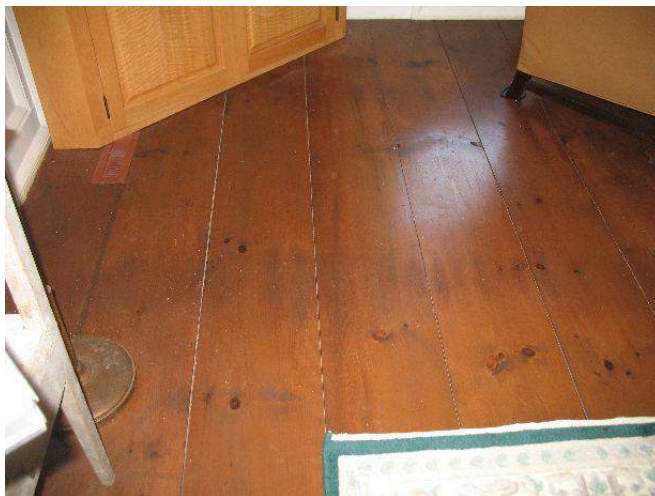
Figure 17

- There are very well kept wide plank floors in the home. See figure 17 above.
- Improve: The use of a dehumidifier in the basement is recommended.
- Improve: If the door to the basement was insulated it would keep the basement warmer.

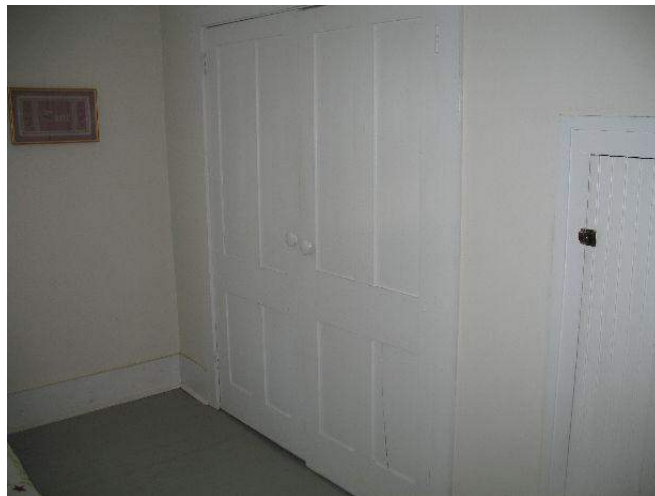
Figure 18

- A fire extinguisher is recommended on each level of the home and in the garage.
- The garage has a crushed stone floor.
- Monitor: There are droppings in the attic which appear to be from bats. No bats were observed at the time of inspection.
- Improve: There was evidence of mice in the attic. Bait stations are recommended to be placed around the outside of the home.
- Empty cans of insect fogger were observed in the attic at the time of inspection.
- One bedroom had double doors on the closet. This makes easy access to the closet space. Very nice. See figure 18 below.
