Property Inspection Report

Charlie and Mary Sample Residential Inspection

Inspection Date:
11/20/06

330 Barnes Road

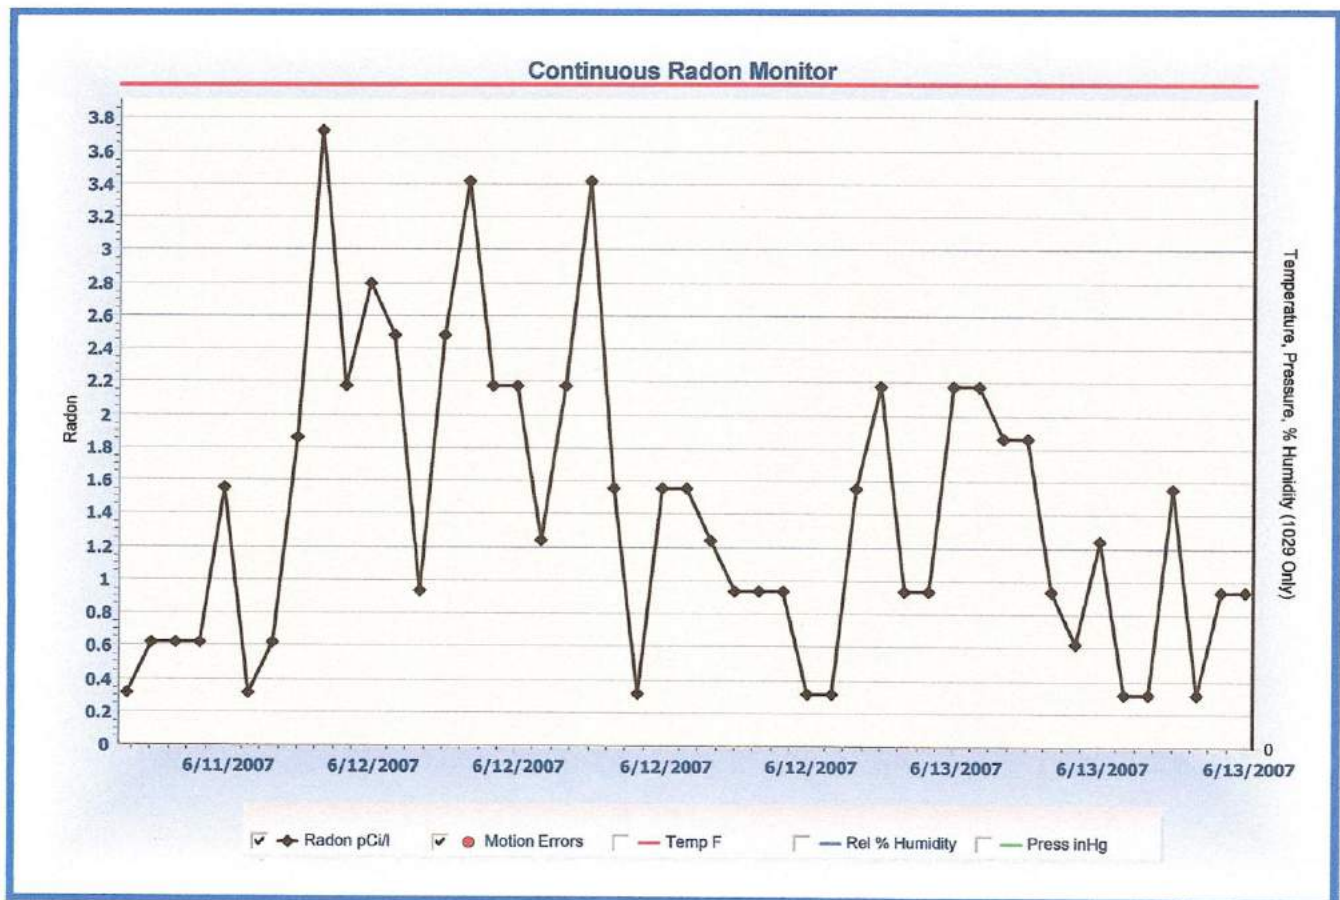
Overall Avg: 1.4 pCi/l
EPA Avg: 1.5 pCi/l

Interpreting This Data: Radon levels are primarily determined by the amount of radon that is in the soil under the building and the air pressures that are present in the house. The amount of radon in the soil is relatively constant. However, the air pressures will vary with such factors as slight changes in wind speed or direction and temperature. Therefore, the hourly radon levels that are recorded in this data will vary. The reported radon result is the average of these hourly readings. The EPA protocols require a two day (46 hour) minimum test period.
